A SYSTEMATIC APPROACH TO IDENTIFYING OPPORTUNITIES FOR MAKING SYSTEMS CONTEXT AWARE TO ADDRESS SAFETY HAZARDS

THESIS

Jared R. Rodriguez

September 2020

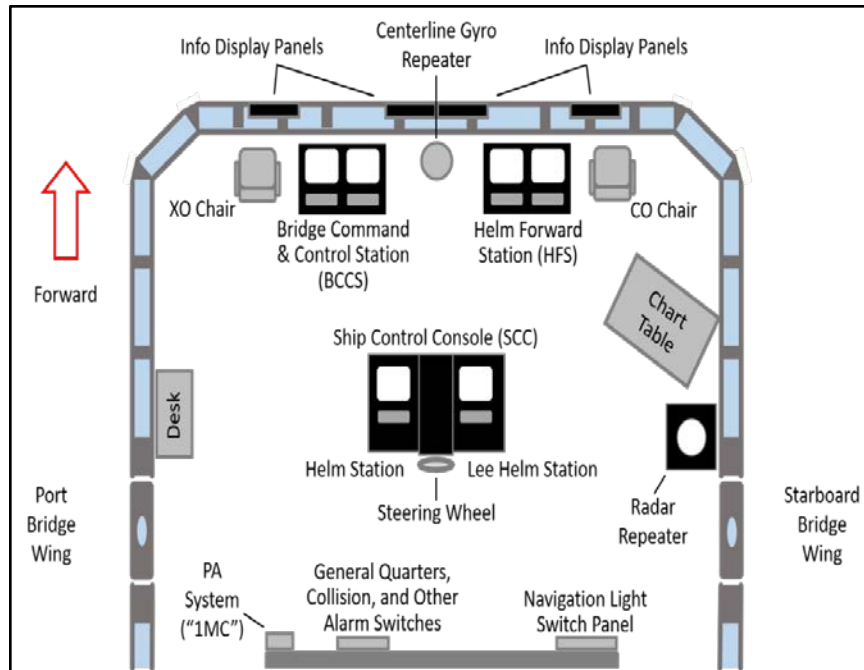
Figure 5. USS *John S. McCain* bridge layout. Source: [6].

Prior to entering the TSS, the CO ordered the Helmsman to shift the Steering Control Console (SCC) from computer-assisted manual mode to backup manual mode. There are several modes that the SCC can operate in. The two modes used onboard JSM are computer-assisted manual mode and backup manual mode. The difference between these modes is how the SCC communicates with the rudder control box. In computer-assisted manual mode, the SCC utilizes computers and software to communicate, where backup manual utilizes copper wire. Aside from the operating modes, there are five locations that a watchstander can drive the ship from. See Figure 5 for the layout of the JSM's bridge. There are four stations on the bridge a watchstander can drive the ship from, and one station known as the Aft-Steering Unit (ASU). The ASU is only manned and utilized in an emergency.

According to the Integrated Bridge and Navigation System (IBNS) technical manual, when in backup manual mode, any other station can unilaterally take control of steering. When in computer-assisted manual mode, the transferring of steering requires the relinquishing station to initiate and the gaining station to acknowledge. This represents a safety-constraint by not allowing any station to just take control of steering. However, by the CO ordering the SCC be shifted to backup manual mode, this safety-constraint is no longer in place and steering can be unilaterally taken by any of the five stations.

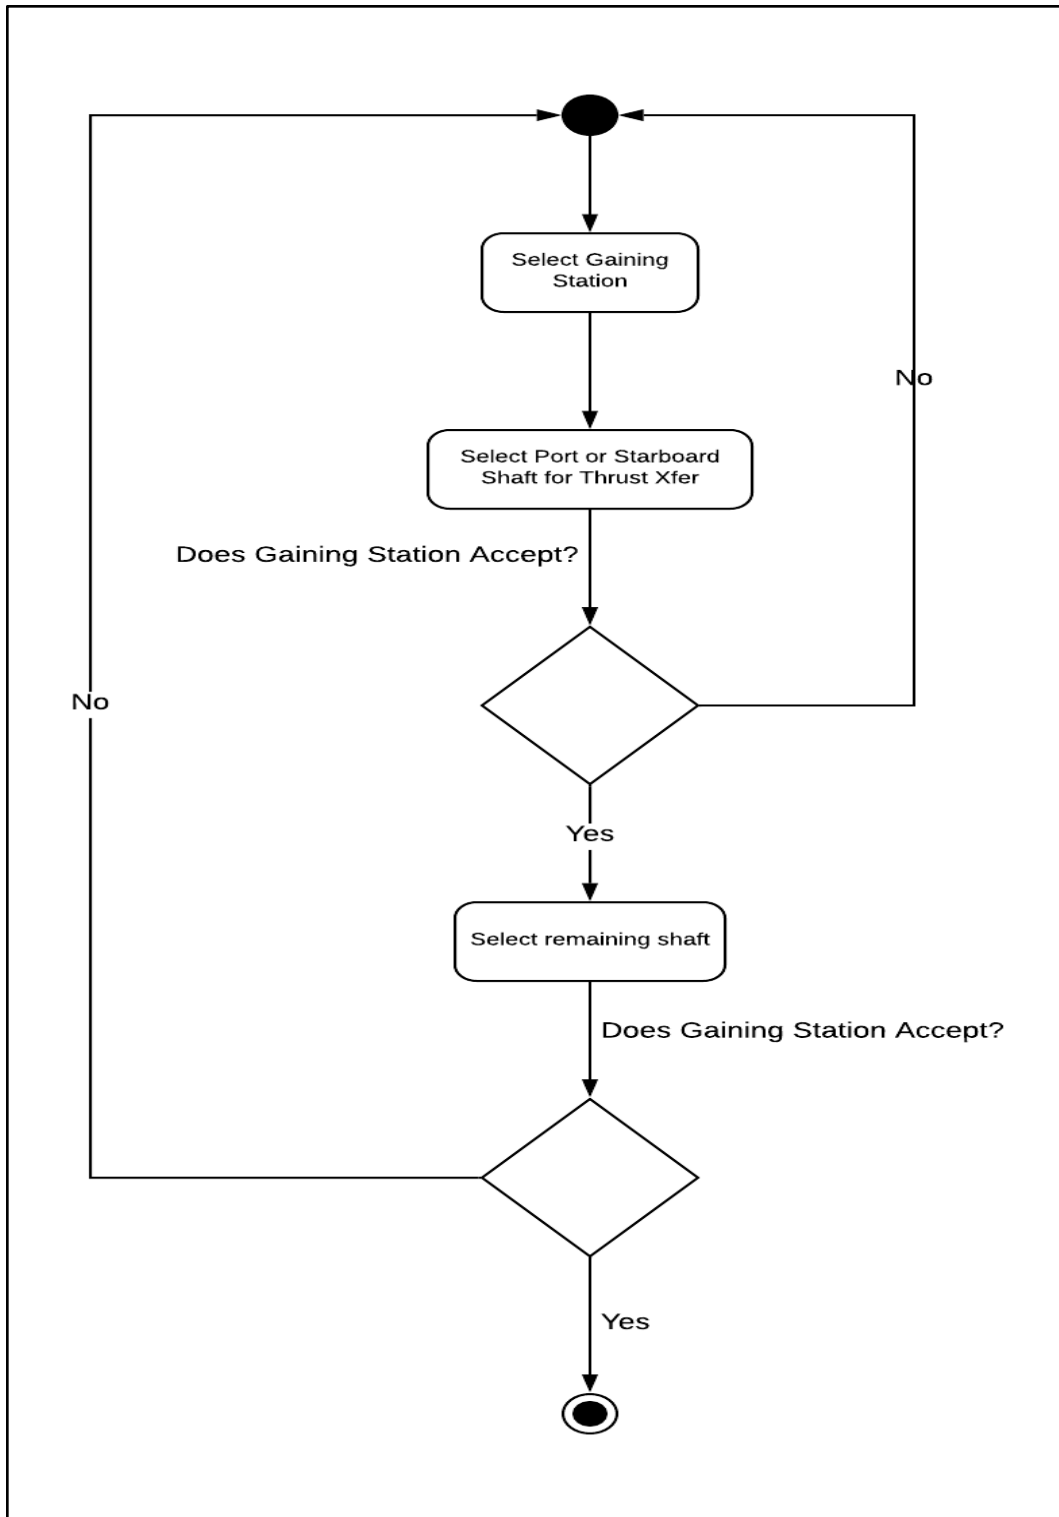
Figure 10. Control actions taken to transfer thrust in computer-assisted manual mode.

Figures 9 and 10 show the control actions required for thrust control transfer in both computer-assisted manual mode as well as backup manual mode. It is quite clear that thrust transfer in backup manual mode has significantly less safety-control measures in place. The most significant safety-control measure in place when operating in computer-assisted manual mode is that the transfer must be initiated by the station that currently has thrust control, and acknowledged by the station that is gaining. This process will be completed twice, once per shaft.

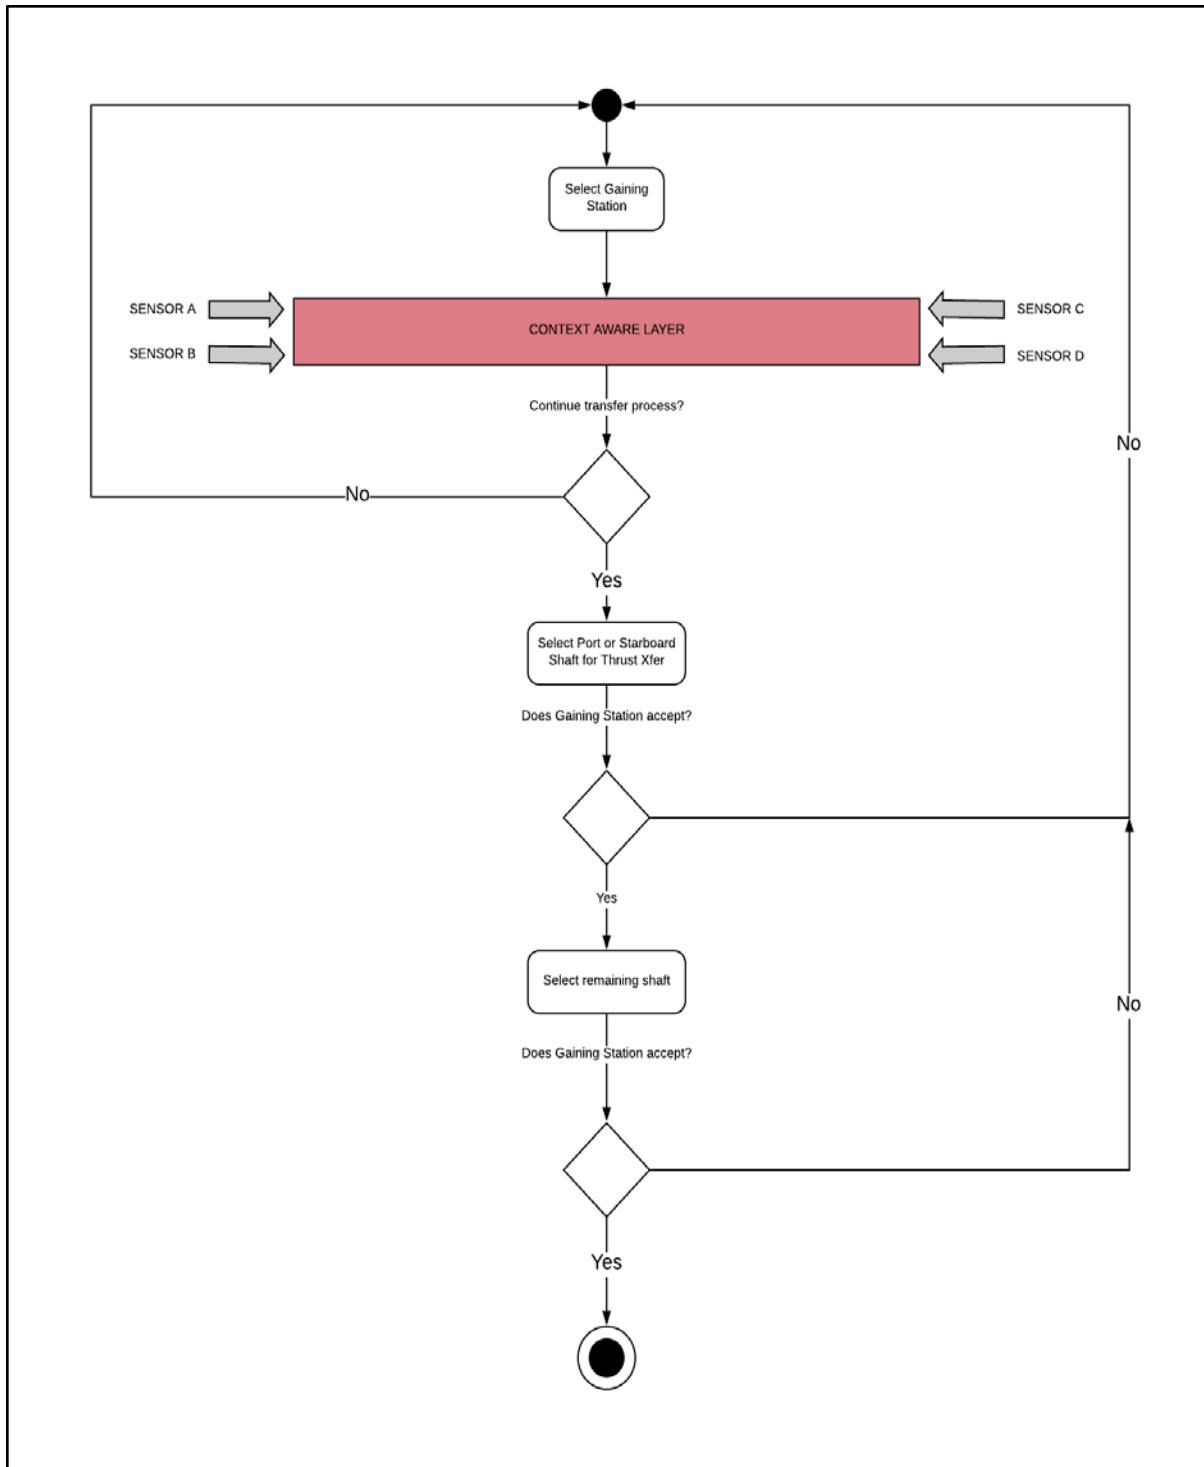
Figure 12. Control actions taken to transfer thrust with context-aware layer.

This same task but with a context-aware layer could be instrumental in creating a safer execution of such operations in all available modes. Figure 11 has an added layer of context-awareness directly after the first control action. The context-aware layer here relies on an array of sensors to provide the human operator with information about the operating environment. The integration into the bridge and navigation system would utilize key sensor feeds from sources such as navigation, RADAR, and system status.

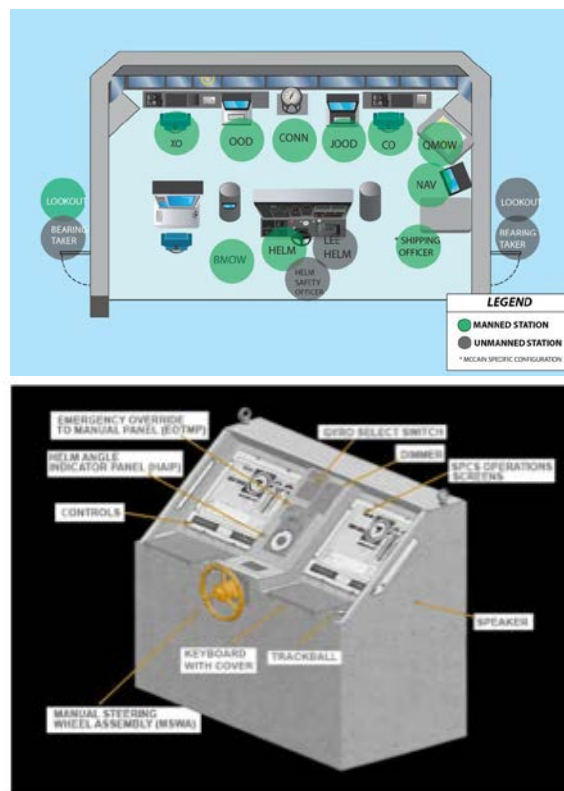
Figure 5 - Illustration of Ship Control Console on JOHN S MCCAIN

At 0519, the Commanding Officer noticed the Helmsman (the watchstander steering the ship) having difficulty maintaining course while also adjusting the throttles for speed control. In response, he ordered the watch team to divide the duties of steering and throttles, maintaining course control with the Helmsman while shifting speed control to another watchstander known as the Lee Helm station, who sat directly next to the Helmsman at the panel to control these two functions, known as the Ship's Control Console. See Figures 3 and 4. This unplanned shift caused confusion in the watch team, and inadvertently led to steering control transferring to the Lee Helm Station without the knowledge of the watch team. The CO had only ordered speed control shifted. Because he did not know that steering had been transferred to the Lee Helm, the Helmsman perceived a loss of steering.

Steering was never physically lost. Rather, it had been shifted to a different control station and watchstanders failed to recognize this configuration. Complicating

this, the steering control transfer to the Lee Helm caused the rudder to go amidships (centerline). Since the Helmsman had been steering 1–4 degrees of right rudder to maintain course before the transfer, the amidships rudder deviated the ship's course to the left.

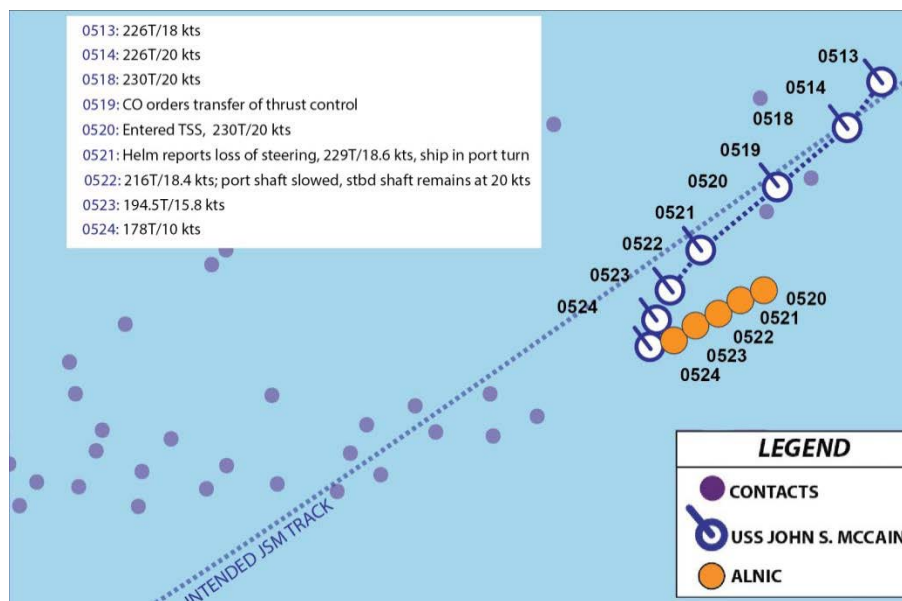
Figure 6 – Illustration Map of Approximate Collision Location

Additionally, when the Helmsman reported loss of steering, the Commanding Officer slowed the ship to 10 knots and eventually to 5 knots, but the Lee Helmsman reduced only the speed of the port shaft as the throttles were not coupled together (ganged). The starboard shaft continued at 20 knots for another 68 seconds before the Lee Helmsman reduced its speed. The combination of the wrong rudder direction, and the two shafts working opposite to one another in this fashion caused an un-commanded turn to the left (port) into the heavily congested traffic area in close proximity to three ships, including the ALNIC. See Figure 5.

Although JOHN S MCCAIN was now on a course to collide with ALNIC, the Commanding Officer and others on the ship's bridge lost situational awareness. No one on the bridge clearly understood the forces acting on the ship, nor did they understand the ALNIC's course and speed relative to JOHN S MCCAIN during the confusion.

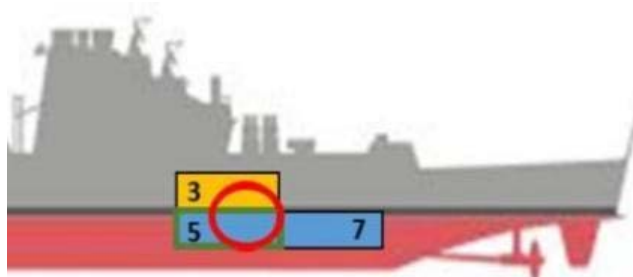
Berthing 5 is located aft (near the back of the ship) on the port side. See Figure 10. It is approximately 25 feet by 15 feet and has 18 racks, stacked as bunk beds three-high. Each row of racks has a locker for Sailors' belongings. There is a lounge with seats, a small table, and a wall-mounted television. There is a head with one toilet, one shower stall, and one sink.

Figure 11 - Relative Positions of Berthings 3, 5 (in green), and 7, and point of impact

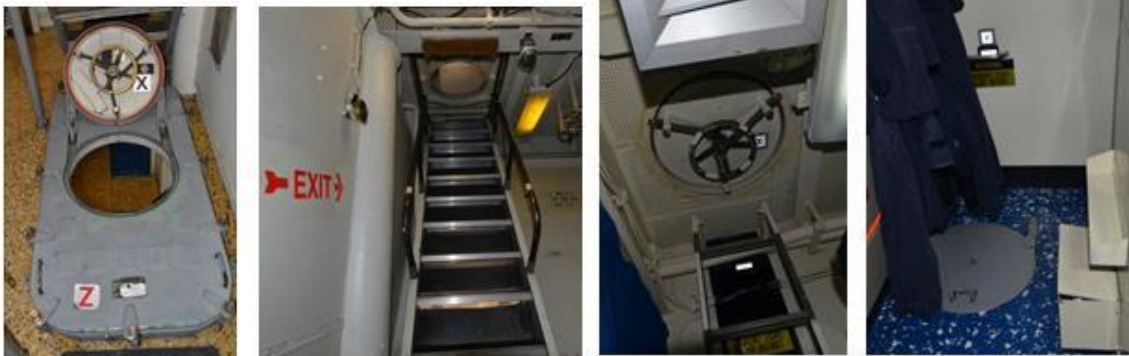
Figure 12 – Primary egress from Berthing 5 Figure 13 – Escape Scuttle from Berthing 5

During Modified ZEBRA, the hatch is closed, but the scuttle is open for ease of access. The escape scuttle is normally closed at all times, as it was at the time of the impact. The collision knocked debris in Berthing 3 on top of the escape scuttle connecting Berthing 3 to Berthing 5 below it. This would have made any attempts to open and exit through the escape scuttle very difficult.

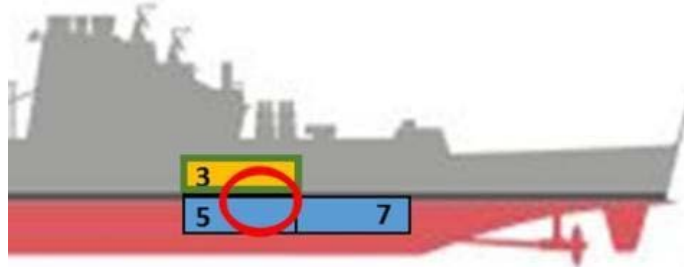
At 0530, the DCA began receiving reports of a ruptured fire main and water and fuel flooding into Berthing 3. The port side of Berthing 3 suffered substantial damage, including a large hole in the bulkhead. See Figure 13. Racks and lockers detached from the walls and were thrown about, leaving jagged metal throughout the space. Cables and debris hung from the ceiling.

Figure 14 - Relative Positions of Berthings 3, 5, and 7 and point of impact
